California Department of Corrections / Mule Creek State Prison

Inspection Date: November 19, 2020

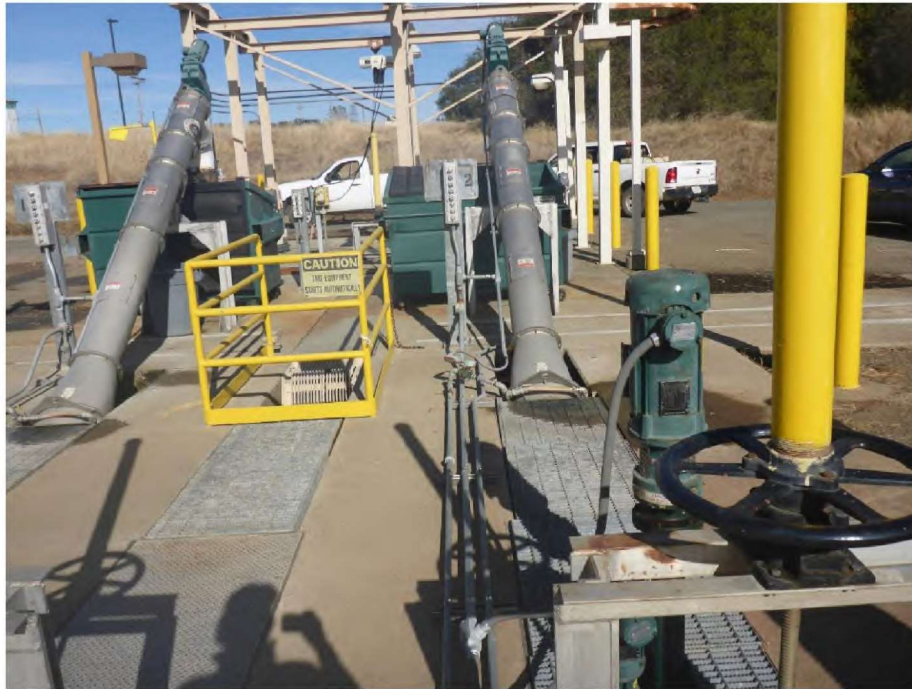
PHOTO 1 In-Channel Grinder and mechanical bar screens

PHOTOS 1-6 show the headworks of the treatment plant at MCSP. At the time of inspection, both in-channel grinders and mechanical bar screens shown in PHOTOS 1-5 were operating. Mr. Orta explained that the grinders and bar screens are essential to wastewater treatment at MCSP because prisoners flush various types of trash down prison toilets. Mr. Orta stated that screens are replaced every 3-4 months, and the whole assembly is occasionally replaced. Mr. Orta explained that an influent sample is taken at the top of the headworks, and the emergency channel (PHOTO 6) can be opened manually if additional flow capacity is needed or if one of the grinders or bar screens becomes inoperable.

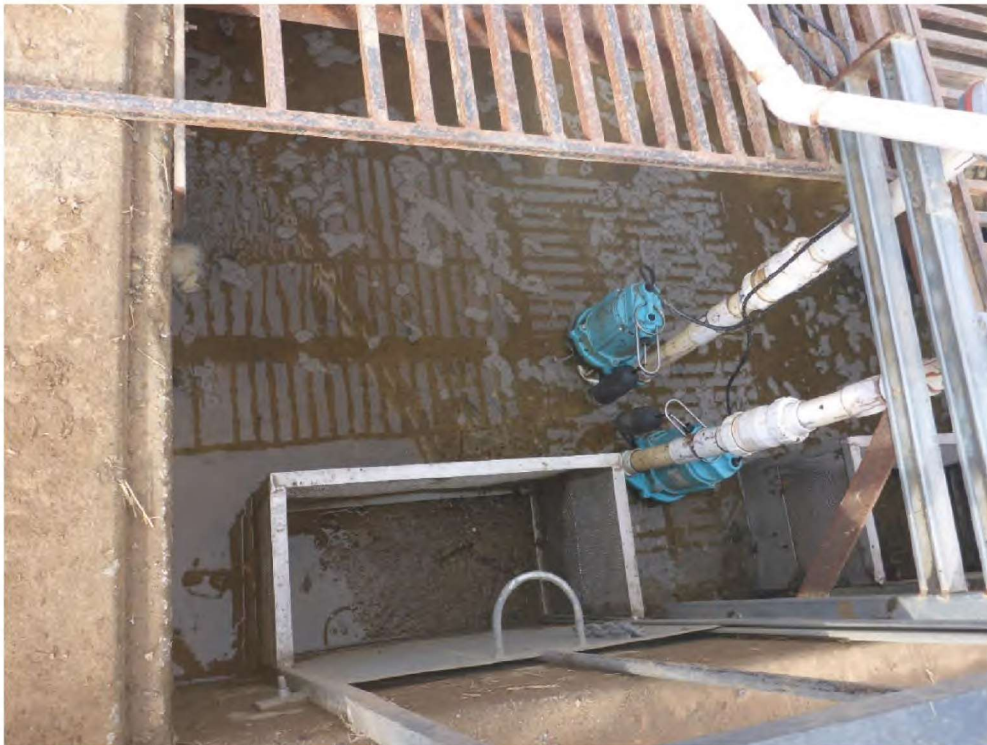
3. **Slide gates do not prevent flow to the main or secondary outfall-** Both sets of slide gates at the main junction vault and secondary junction vault do not fully seal when in the "closed" position, allowing water to pass through the gates to the outfall. Potentially commingled and contaminated waters could flow to the outfall unchecked. Unpermitted discharge reaching Mule Creek could result in a violation of the WDR or MS4 Permit.

Photo 8 – Closeup of secondary junction vault with pumps, screens, and two closed slide gates.
Pumps were not operating at time of observation.

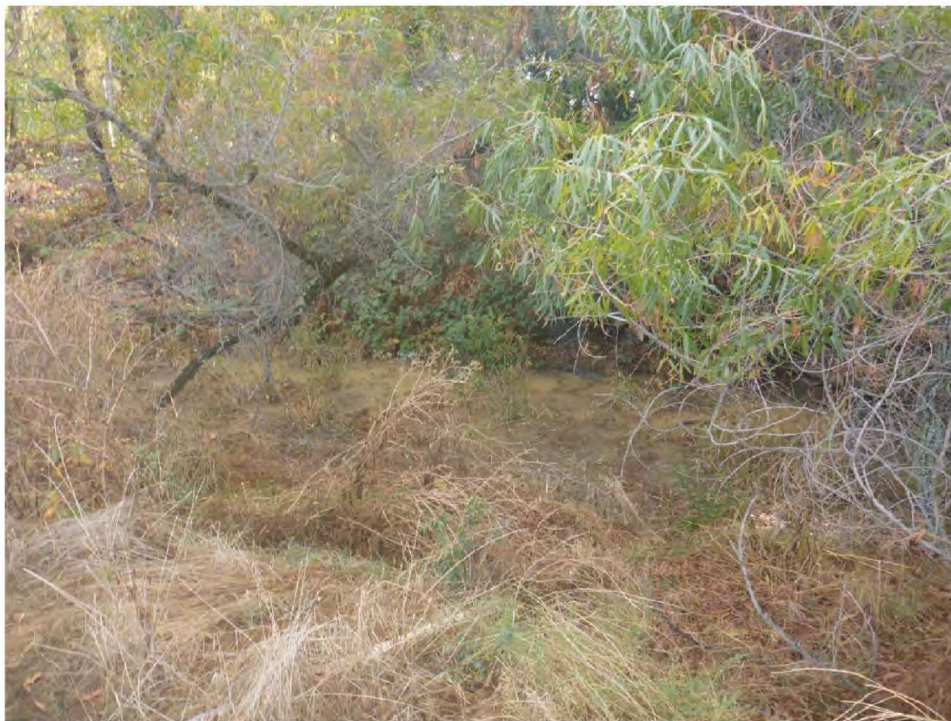
PHOTO 14 – Drainage channel with water

and is sampled for the same parameters compiled in the weekly monitoring report. Inspectors Scavello and Tinger walked the length of the drainage channel shown in PHOTO 14 and PHOTO 15, which was not flowing but contained water.

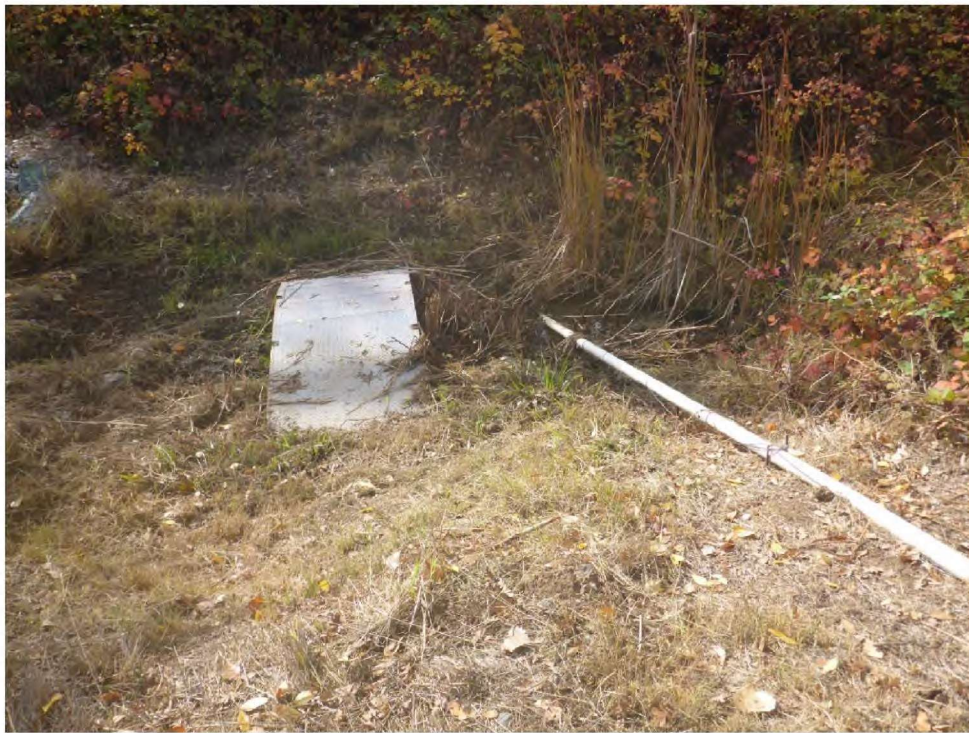
PHOTO 16 – MCSP-3 Point of compliance

PHOTO 16 shows the MS4 point of compliance for the MCSP-3 sample point. At the MCSP-3 sample point Inspector Scavello and Mr. Stark discussed sampling protocols. Mr. Stark explained that this sample is taken at a consistent point just downstream off of the bridge shown in the photo, and that either he or another trained operator collects a grab sample. Mr. Stark explained that training for new sampling requirements under the MS4 program are being disseminated to all operators.

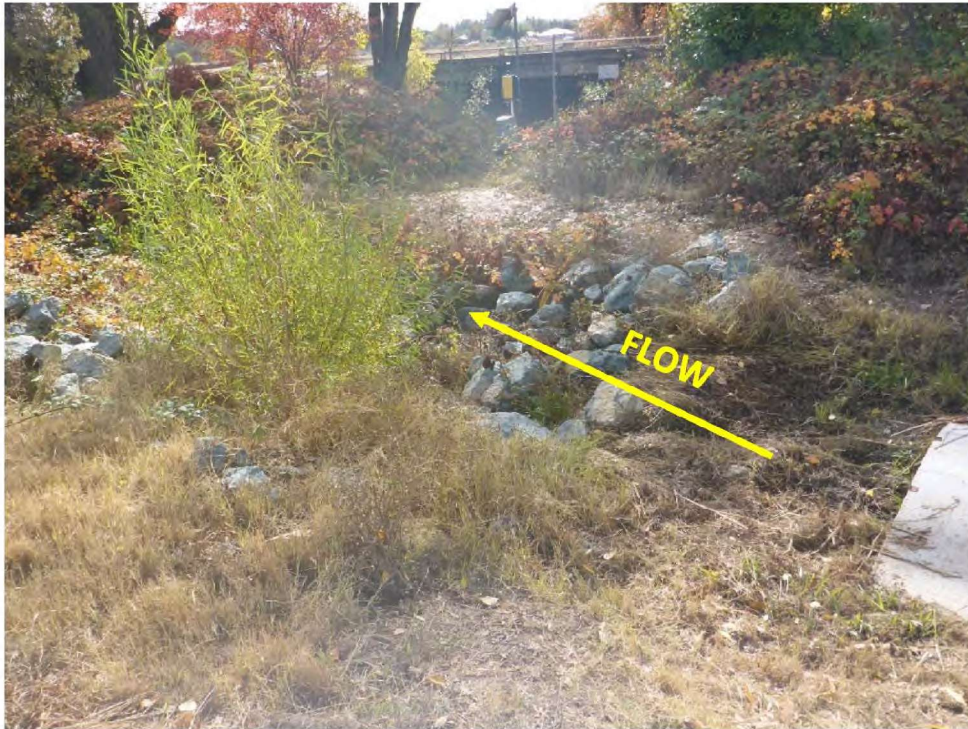
PHOTO 17 shows the MCSP-3 sample point. APPENDIX 2 shows the surface drainage route from the main outfall to MCSP-3. Mule Creek connects to the MCSP drainage area shortly after the bridge shown in the background of PHOTO 17 at an estimated distance of 300 feet from sample point MCSP-3. The drainage channel in this area had wet soil but no consistent standing water at the time of inspection.

PHOTO 17 – Compliance point MCSP-3. Bridge connecting to Mule Creek in back center of photo.

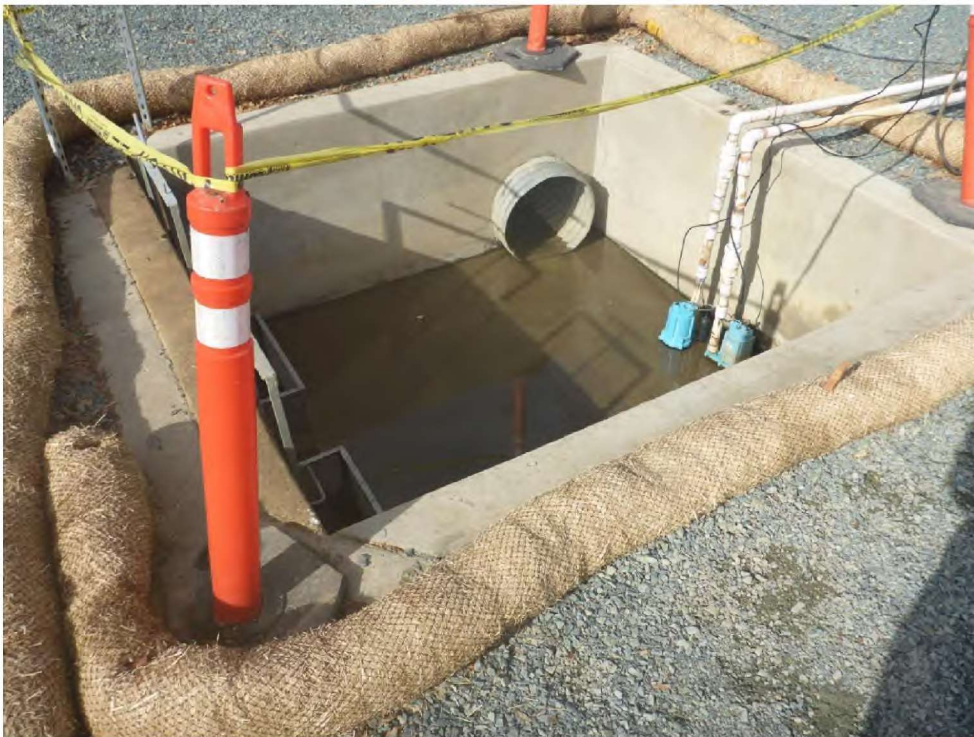
PHOTO 18- Main Junction Vault

PHOTO 18 shows the main junction vault, PHOTO 19 shows the main outfall, and PHOTO 20 shows the MCSP drainage channel reach directly after the main outfall. Mr. Hudgens explained that 45 acres drain to the main junction vault, and that the distance is approximately 1500' from the main outfall to MCSP-3. Mr. Hudgens also explained that major construction work on the main junction vault was completed at the end of 2019, and that this construction consisted of adding three new walls to the vault. Mr. Larabee explained that prior to this construction work the main junction vault was an open pit on the three sides that with one headwall and the two slide gates. At the time of inspection, the drainage pipes terminating into the main junction vault had no flow and both slide gates were closed (PHOTO 18).

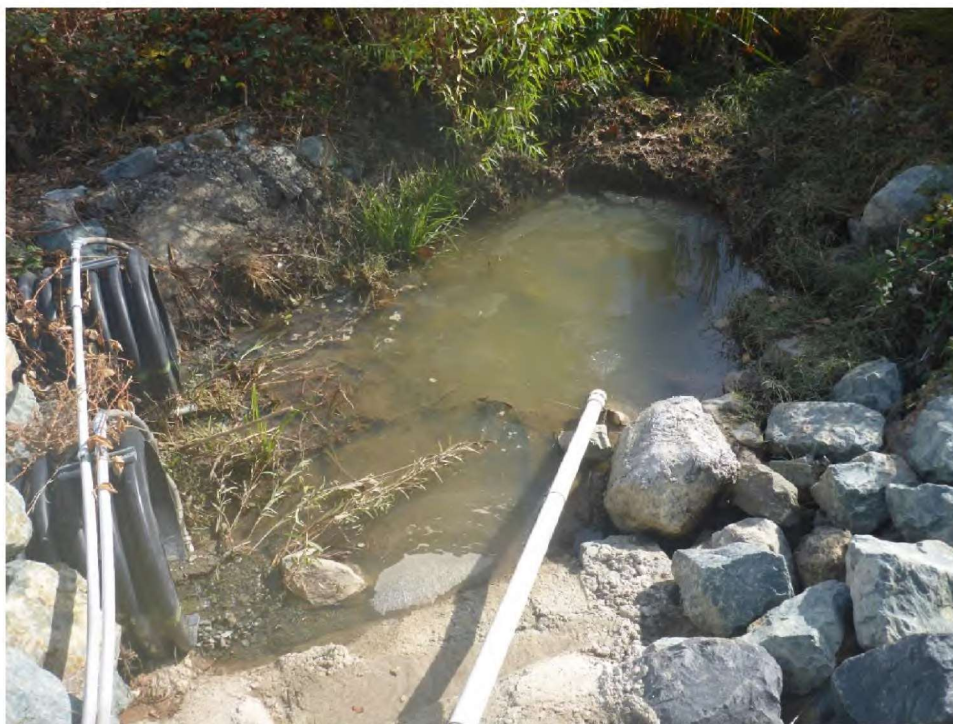
At the main outfall, there was a small amount of flow exiting both pipes. Mr. Hudgens explained that this flow, as with the secondary outfall, is from the small amount of water that is able to seep under the slide gates. EPA Inspectors were informed that the only sampling at this outfall point is via the ISCO sampler shown in PHOTO 19 and results are included in the weekly SHN report.

PHOTO 19 – Main outfall with autosampler point MCSP-6

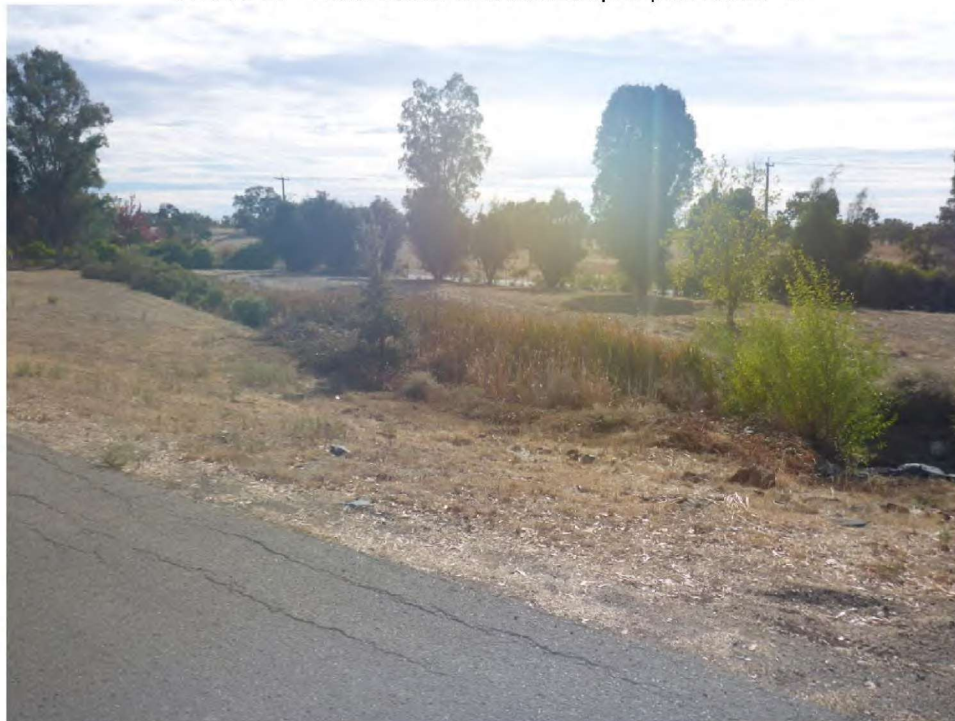
PHOTO 20 – Drainage channel reach directly beyond main outfall leading to MCSP-3

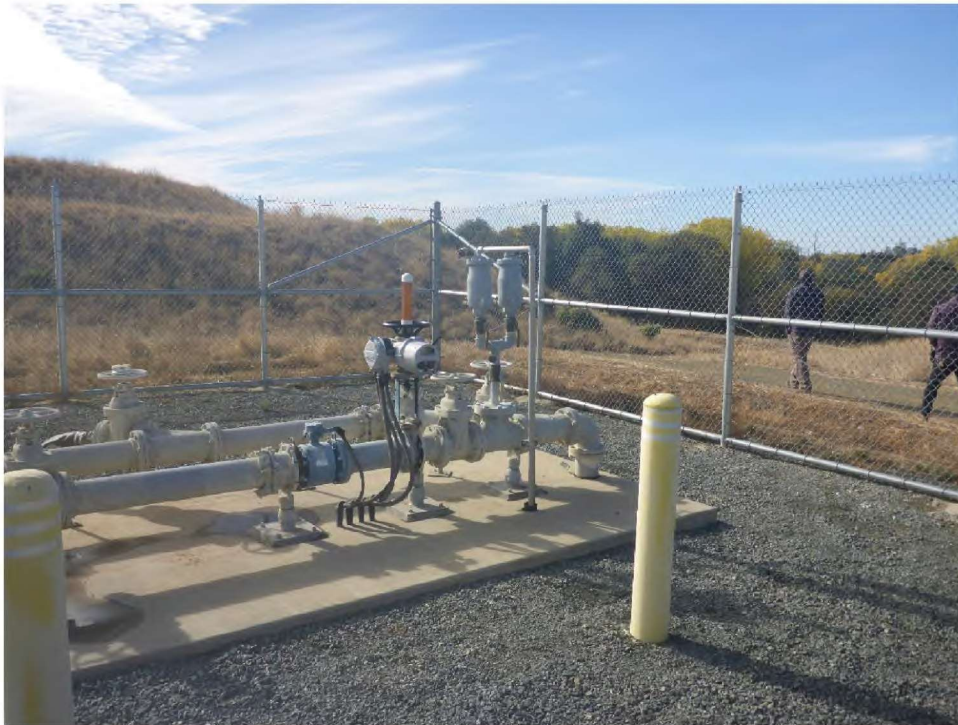
PHOTO 21 – Pump station manifold

The inspection continued at the pump station located adjacent to the wastewater treatment plant (PHOTOS 21-22). Mr. Stark explained that this pump station collects water from the MCIC and transfers it to the wastewater treatment plant. Chopper pumps cut up trash prior to flowing this water to the headworks. Inspector Scavello discussed a sanitary sewer overflow (SSO) which was reported on August 11, 2020 with Mr. Fregeau and Mr. Stark. A portion of this spill report form used by MCSP and the spill notification report sent to the Regional Board is shown as APPENDIX 7 below.

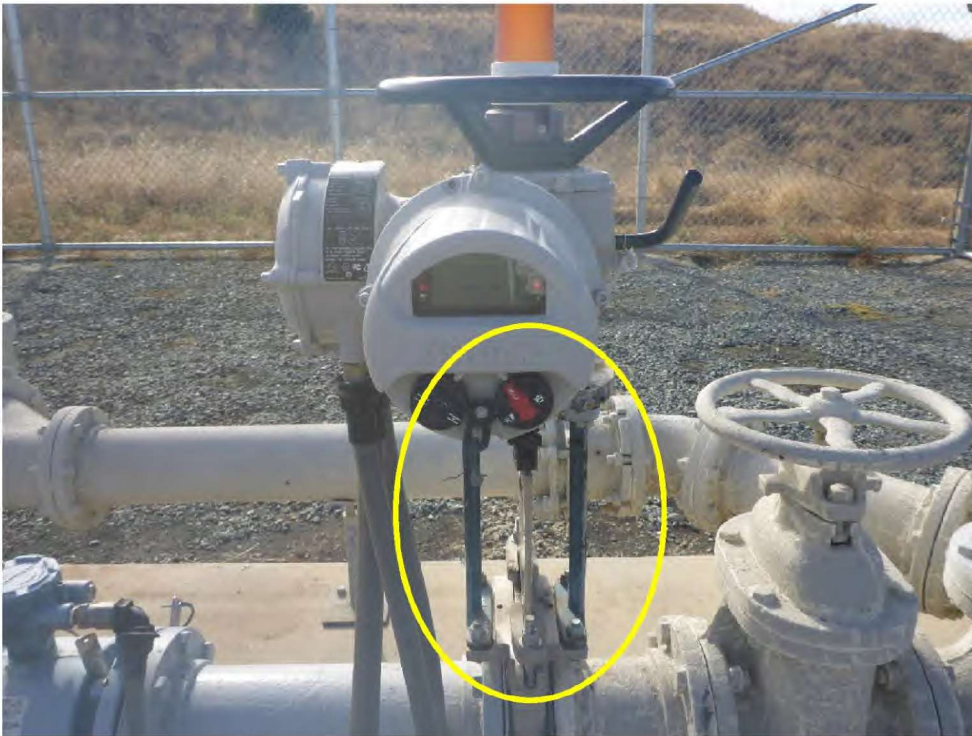
Mr. Fregeau and Mr. Stark explained that it was determined that faulty code in the operating system for the knife gate shown in PHOTO 23 caused the gate to remain in the 'closed' position while the pump station was pumping, triggering the SSO. At the time of the SSO, Mr. Fregeau explained that Facility practice was to leave the emergency valve in the berm shown in PHOTO 24 in the 'open' position during summer months. The SSO flowed through the open valve to the areas shown in PHOTO 25 and PHOTO 26, and a vac truck was used to recover an estimated 11,100 gallons that were not absorbed into the creek bed shown in PHOTO 26. Mr. Fregeau's spill report notes the total spill estimate as 42,227 gallons based on previous day "normal" flow, and that based on SCADA data the "PLC for MCIC faulted at 7:00PM on Monday, August 10th, 2020. It was not discovered till Tuesday, August 11th, 2020; approximately 11:15AM". After the inspection, Inspector Scavello verified that this information matched reporting in Cal OES. The spill was reported in Cal OES as control #20-4297.

PHOTO 23- Knife gate manually place in the "open" position

As a result of this spill, Mr. Fregeau explained that the emergency valve in PHOTO 24 is now kept in the 'closed' position, and the knife gate is kept in the 'open' position as shown in PHOTO 23. Inspector Scavello verified that the valve was closed and knife gate was open at the time of inspection. Mr. Fregeau also explained that since this spill the mobile pump seen in PHOTO 22 is staged at the pump station in case of emergency.

5. **Incomplete spill reporting data-** The Spill Notification Report shown in Appendix 7 notes a spill start time of 7:00PM on Monday, August 10th, 2020 and discovery/stoppage at 11:15AM on Tuesday, August 11th. The "estimated volume spilled" section of the report notes "Based on previous day flows I estimate we were under the "normal" flow amount about 42,227 gallons." This description is non-specific and does not allow a reader reviewing the report to know what flow is being referenced, or what a "normal flow" is. By not specifying the source of flow or what constitutes a normal flow, it is not possible for the reader to verify the accuracy of the spill amount. Also, the "corrective actions" section of the report lists installation of a float activated standalone alarm system to prevent a similar spill from occurring. At the time of inspection EPA Inspectors did not observe this corrective action in place and operable.

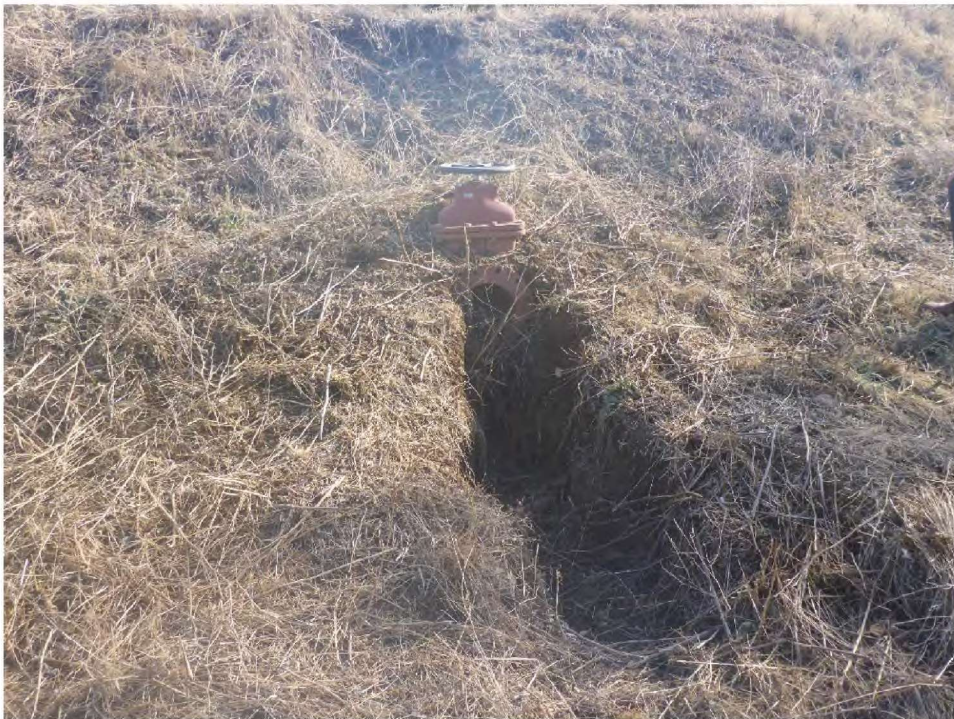
PHOTO 24 – Emergency valve in berm where August 11, 2020 SSO flowed through

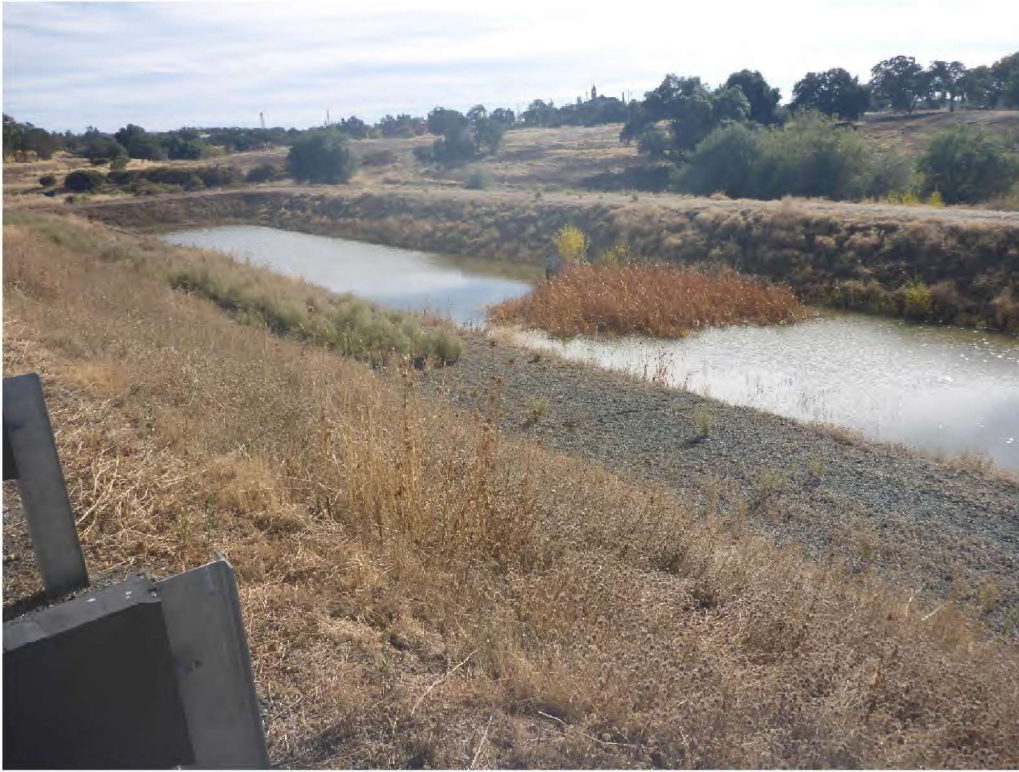
PHOTO 27 – Stormwater pond

Mr. Stark explained that the stormwater settling pond shown circled in yellow on the map at right and pictured in PHOTO 27 collects stormwater from the MCIC yard and building areas. Mr. Hudgens explained that the settling pond was constructed in 2016 simultaneous with MCIC construction. The settling pond contains an overflow pipe, which the 2020 MCSP Sewer System Management Plan (SSMP) notes drains to Mule Creek once the pond has reached approximately half capacity⁵. At the time of inspection, the water level was far below entering the overflow pipe. The pond appeared to be structurally sound at the time of inspection.

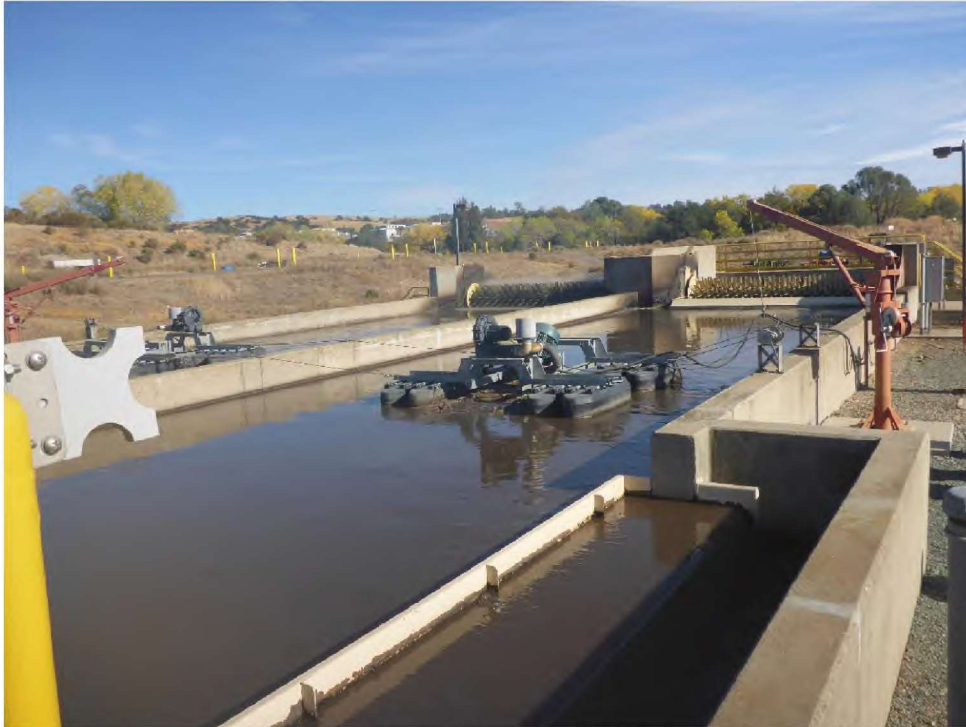
PHOTO 28 – Oxidation ditch

After wastewater passes through the in-channel grinder and bar screens described earlier, an influent pipe delivers wastewater to the oxidation ditch (PHOTO 28). At the time of inspection, the aerators pictured were running alternately. Mr. Stark explained that the high-powered additional pumps shown in PHOTO 28 are generally not used, as they increase flow velocity to too high a rate. He explained that all aerators operate year-round. Mr. Stark explained that the wastewater flows around the oxidation ditch curve shown in PHOTO 29 to a splitter box, and that wastewater can be directed to clarifier #1, #2, or #3. At the time of inspection all flow was being directed to clarifier #3. Mr. Stark informed the EPA inspectors that MCSP staff was working on guide arm maintenance on clarifiers #1 and #2. Clarifiers #1 and #2 were not operating at the time of inspection. PHOTO 30 shows the condition of wastewater in clarifier #3, which appeared to be operating in good repair. PHOTO 31 shows clarifier #2. PHOTO 32 and PHOTO 33 show the full extent of the oxidation, aeration, and clarifying operation at the wastewater treatment plant.

6. **Impacts of cold weather on uncovered wastewater treatment plant-** As acknowledged by MCSP staff during the inspection, the lack of cover over the wastewater treatment plant has the potential to reduce biological effectiveness during winter months.

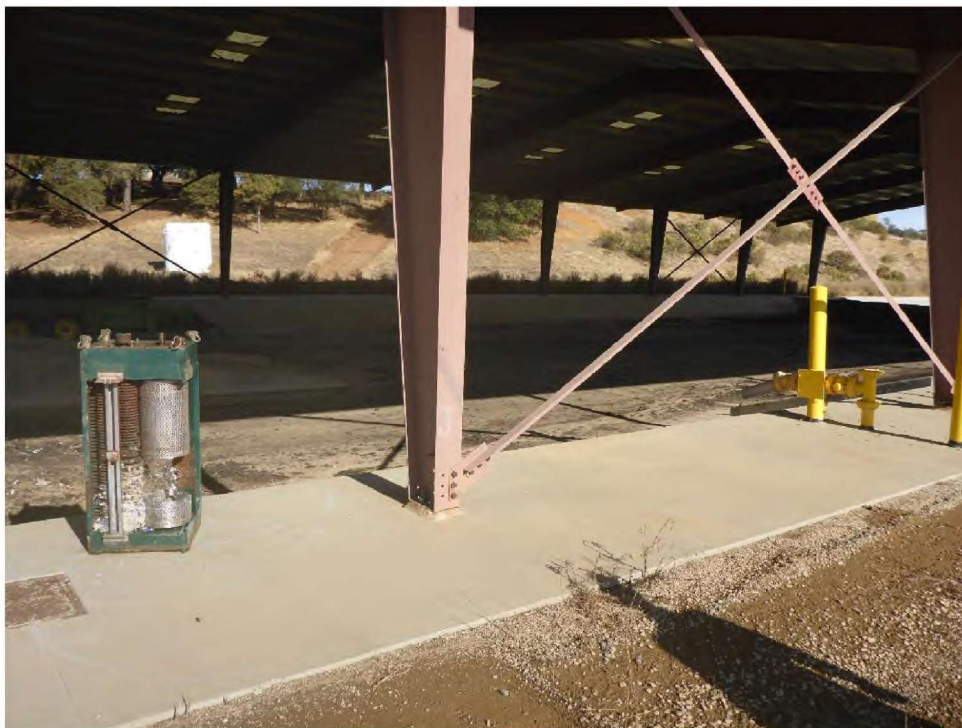
PHOTO 34 – Covered sludge drying bed

Mr. Stark explained that in warmer months, sludge is sent to the drying beds shown in PHOTO 34, and in the winter months that sludge is pressed using the belt press shown in PHOTO 35 and placed into a dumpster for removal. Mr. Stark commented that average daily flow at the wastewater plant is 480,000-520,000 gallons per day⁶, and that the plant usually wastes 10,000-15,000 gallons of sludge per day. Mr. Stark explained that residual wastewater from the drying beds flows back to the oxidation ditch.

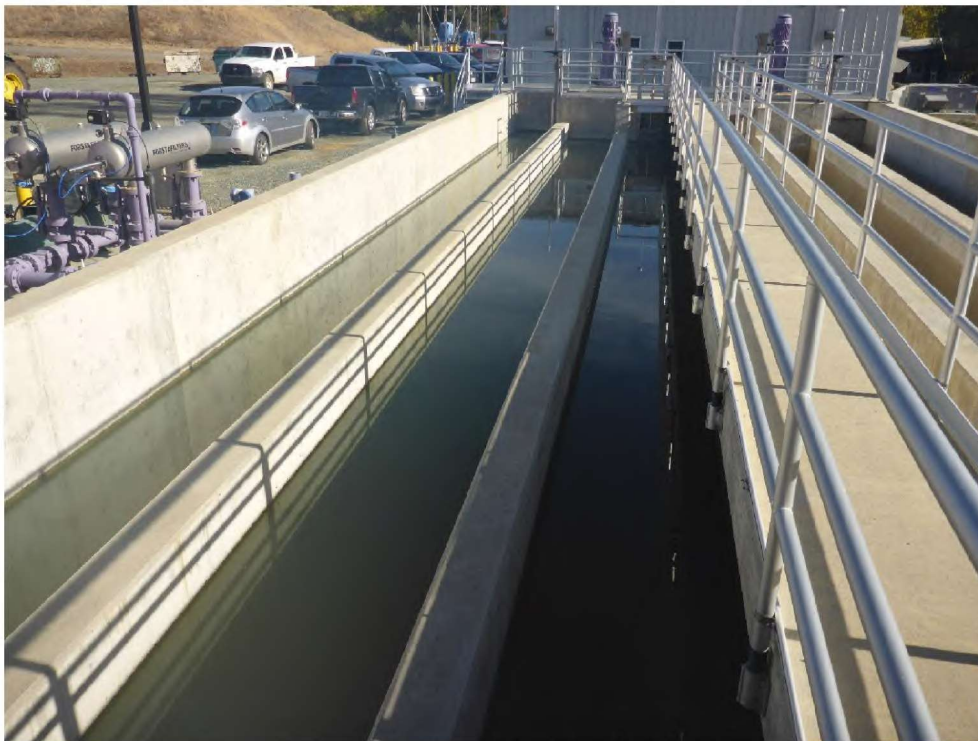
PHOTO 36 – Chlorine contact chamber

After the wastewater is clarified, it enters the chlorine contact chamber shown in PHOTO 36. Mr. Stark commented that average flow time for wastewater in the chlorine contact chamber is 1.5 hours. As stated in the WDR, treated wastewater is sent to MCSP Reservoir, Preston Reservoir, Castle Oaks Reclamation Plant for reuse/land application, or disposed of via land application areas on-site within the MCSP.

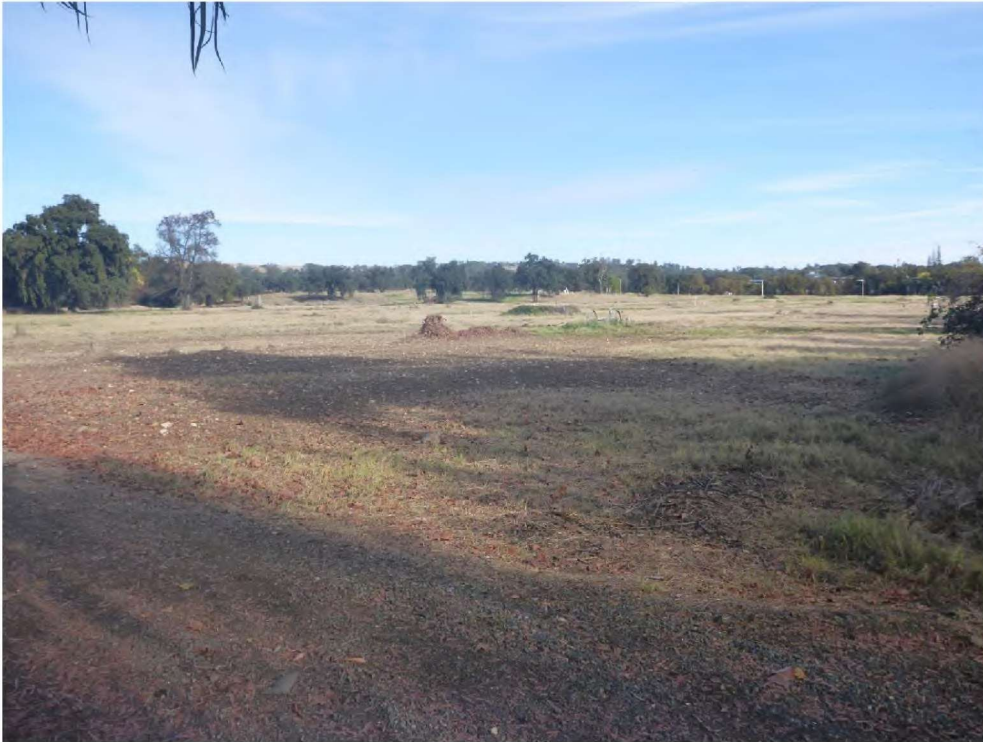
PHOTO 37 – LAA #7

EPA Inspectors Scavello and Tinger and other inspection attendees viewed LAA #7, the nearest adjacent LAA location to the Mule Creek discharge point (PHOTO 37). At the time of inspection, the field was not being irrigated. Mr. Stark explained that the LAA was last irrigated one week prior to the inspection, and that when a field is being irrigated sprinklers run until the field is saturated to the point that a visual determination is made that no ponded (i.e. standing) water will be present 24 hours after irrigation is stopped. MCSP staff explained that irrigation frequency is intermittent based on the volume of treated wastewater present in the storage pond and weather conditions, and that fields are irrigated in rotations according to the WDR guidelines. Mr. Hudgens explained that the sprinklers at MCSP LAAs are designed with a 40-foot setback from a road and a 60-foot setback from waterways. This distance is measured from the edge of where the LAA sprinkler is spraying water to the road or waterway.

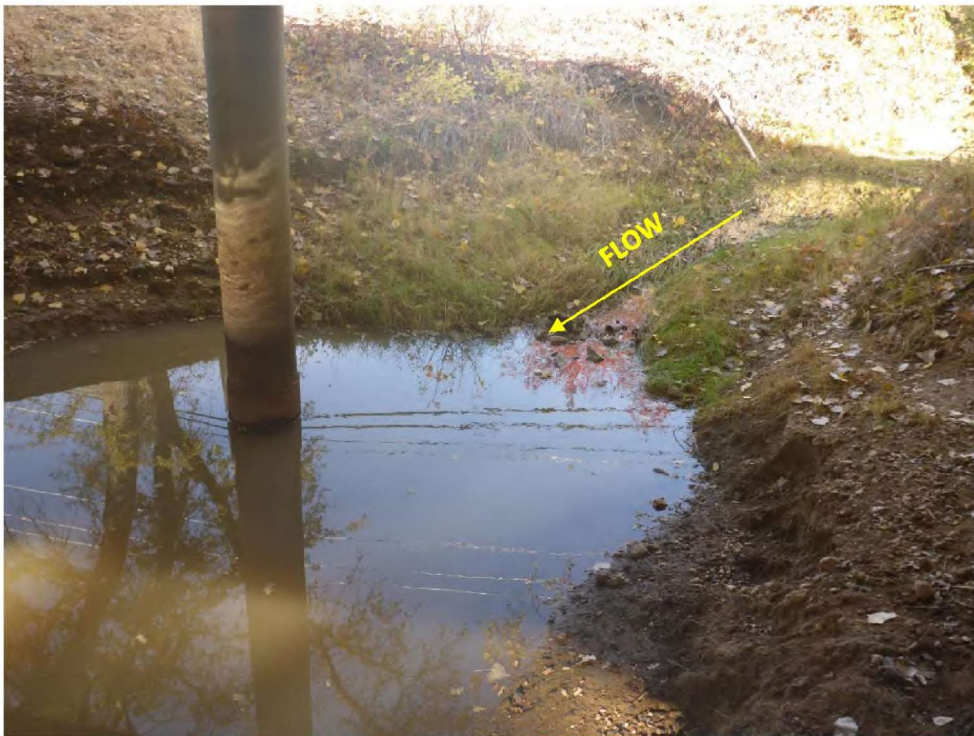
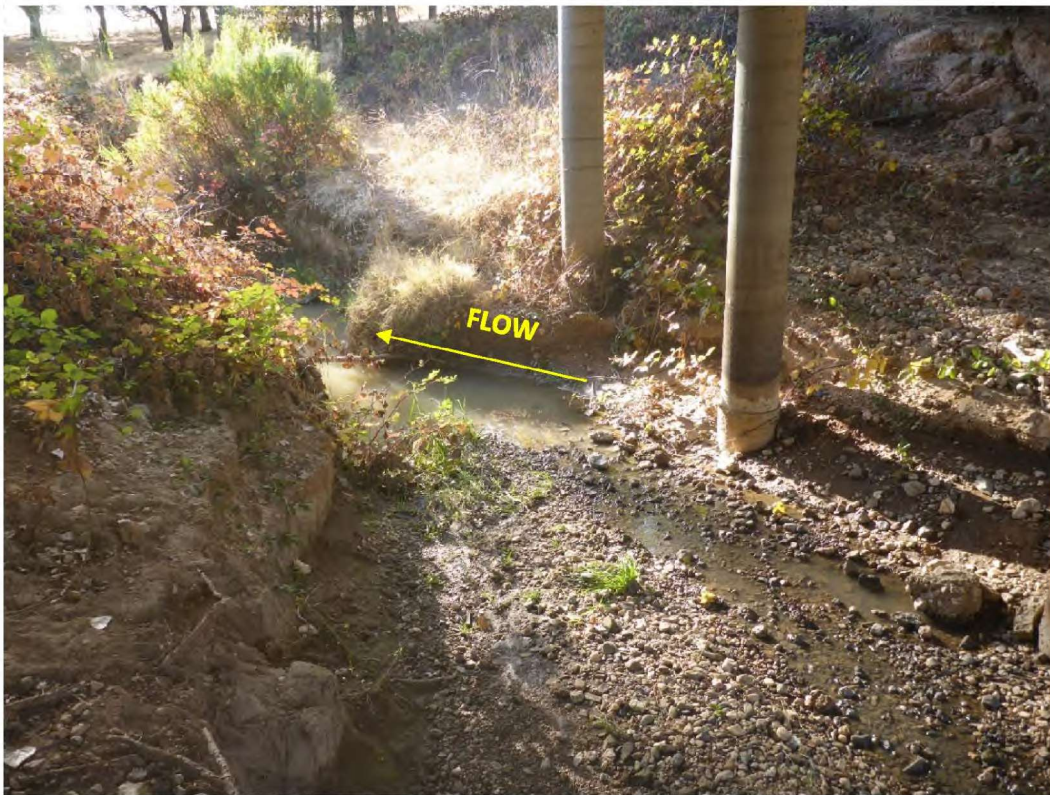
PHOTO 38 – Outfall point under bridge where MCSP drainage joins Mule Creek

After a closing conference with MCSP staff in which initial areas of concern were discussed, Inspectors Scavello and Tinger and Regional Board staff inspected Mule Creek immediately downstream from the surface drainage area where stormwater exits MCSP and connects to Mule Creek. This area is shown in PHOTO 38 and PHOTO 39, and is located underneath the bridge overpass of CA-104 approximately 20 feet southwest from sample point MCSP4/RW. Water was not flowing at the time of inspection, and pooled water under the bridge area was muddy with no foam.
